# Whiskers on USB housing of PC Mother Board

## September 5, 2008

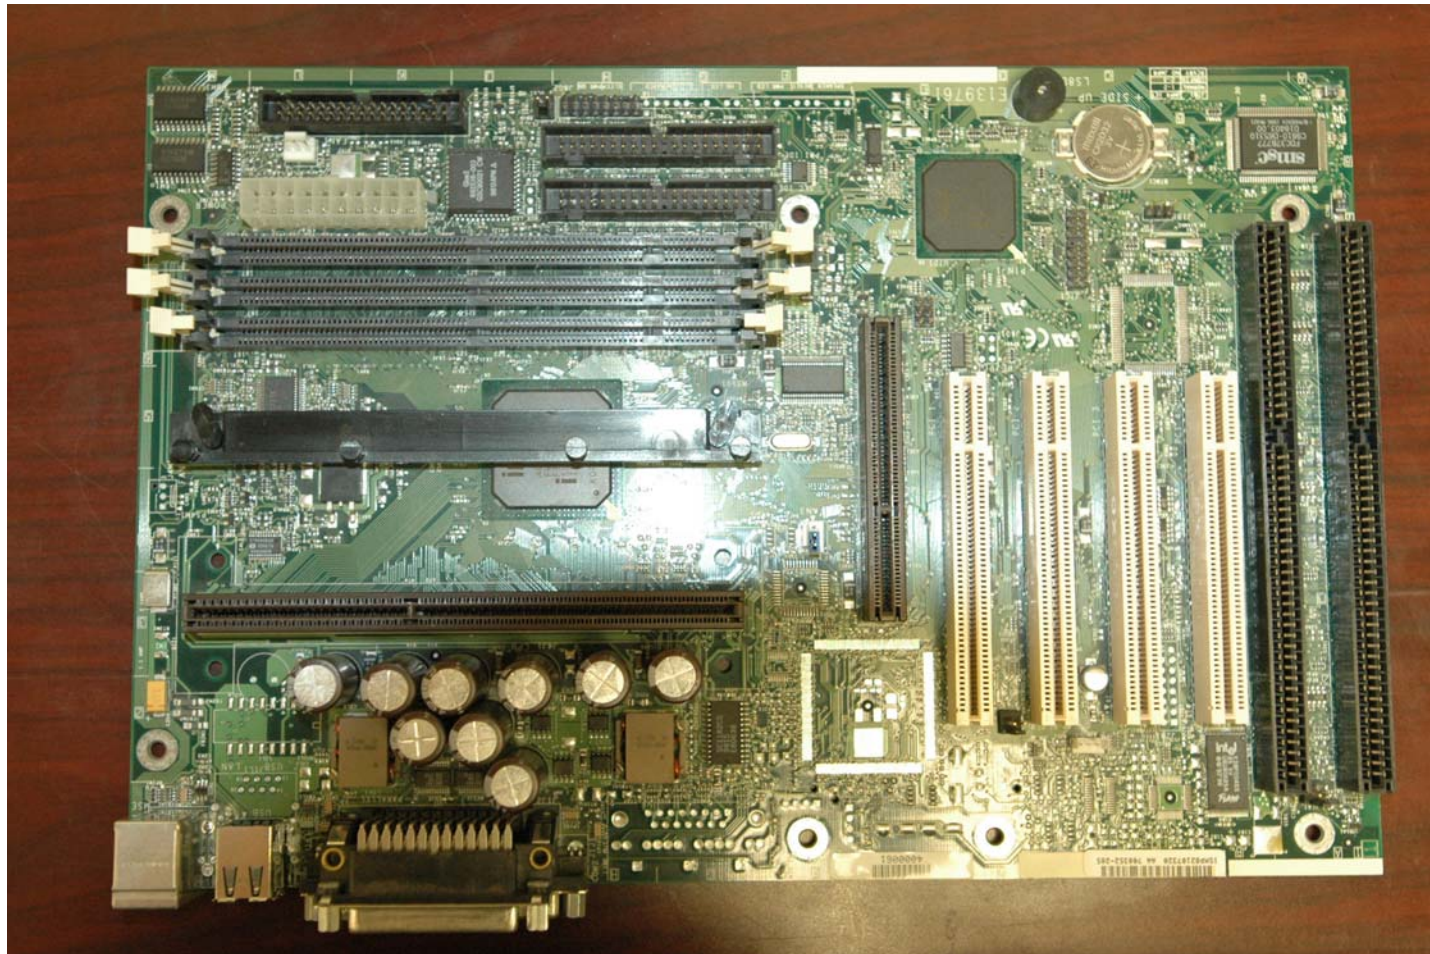
# Top Surface

- A PC motherboard was examined for presence of tin whiskers.
- Tin whiskers were observed on USB housing.
- Observed whiskers were long enough to bridge fine pitched perimeter leaded packaged integrated circuits on the PWAs.

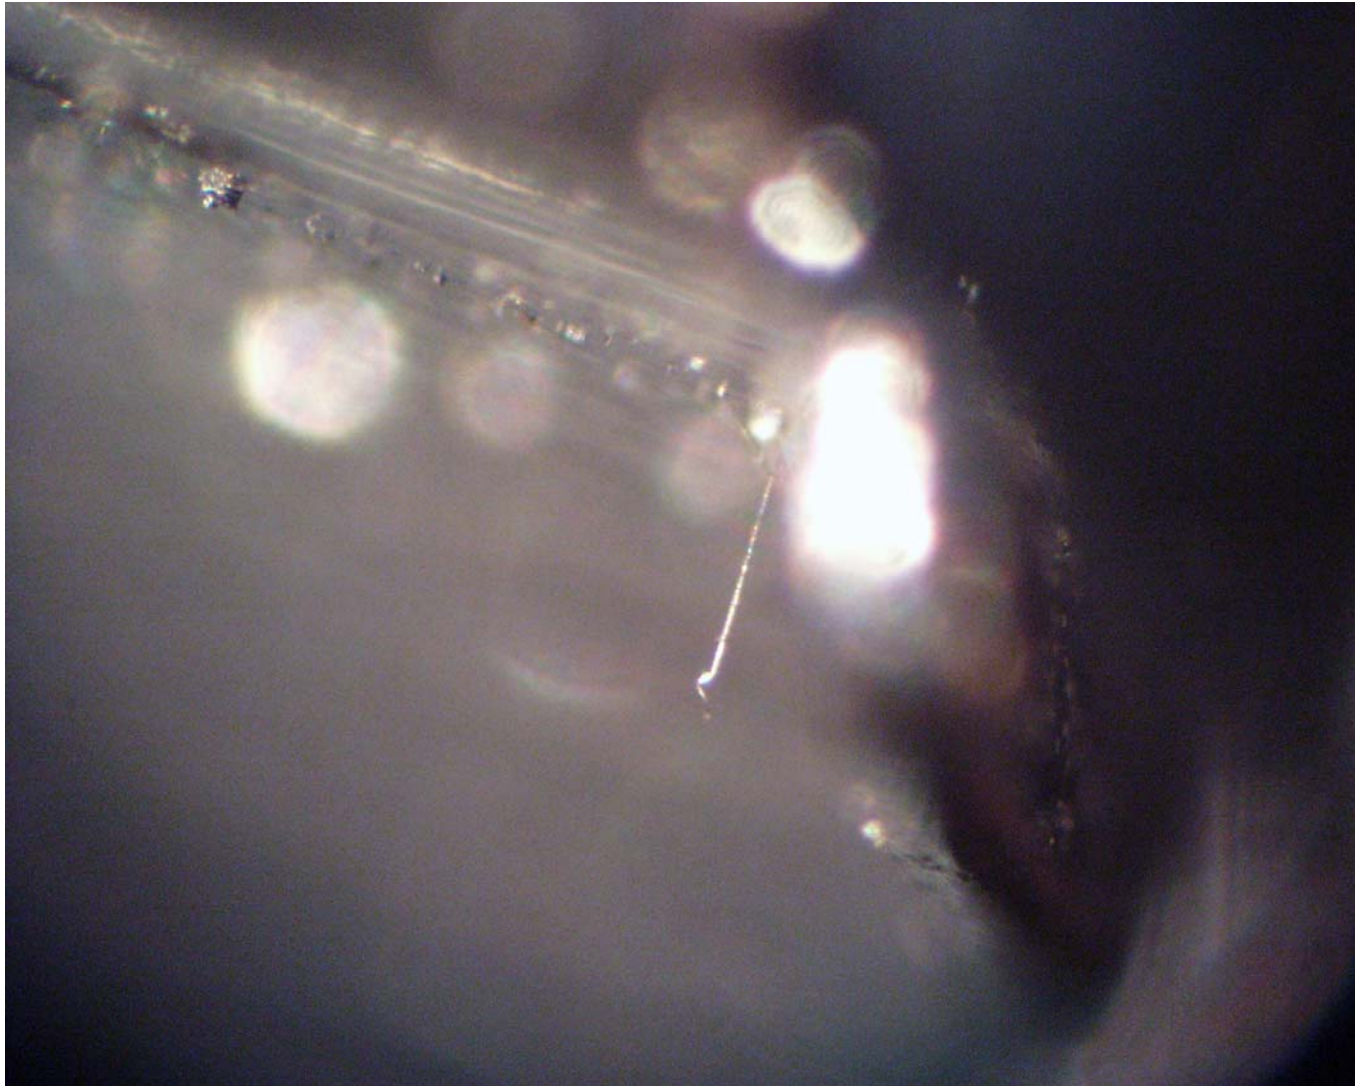
# Optical View of Long Whisker on USB Housing

- XRF analysis of USB housing found ~8 micron thick tin over copper.
- Whisker greater than 900 microns were observed on USB housing.
- Whisker could become dislodged and create a reliability issue.

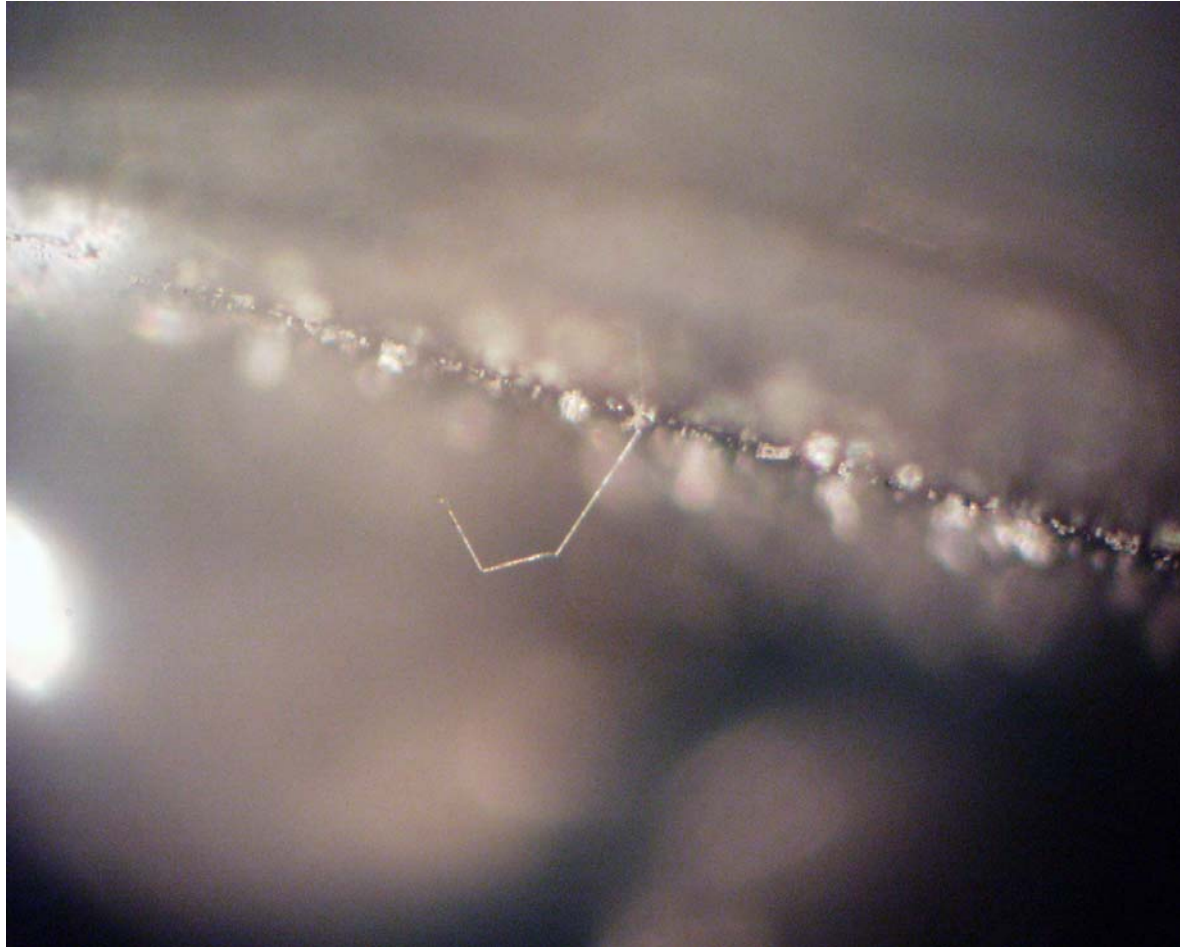
# Optical View of Whisker On USB Housing

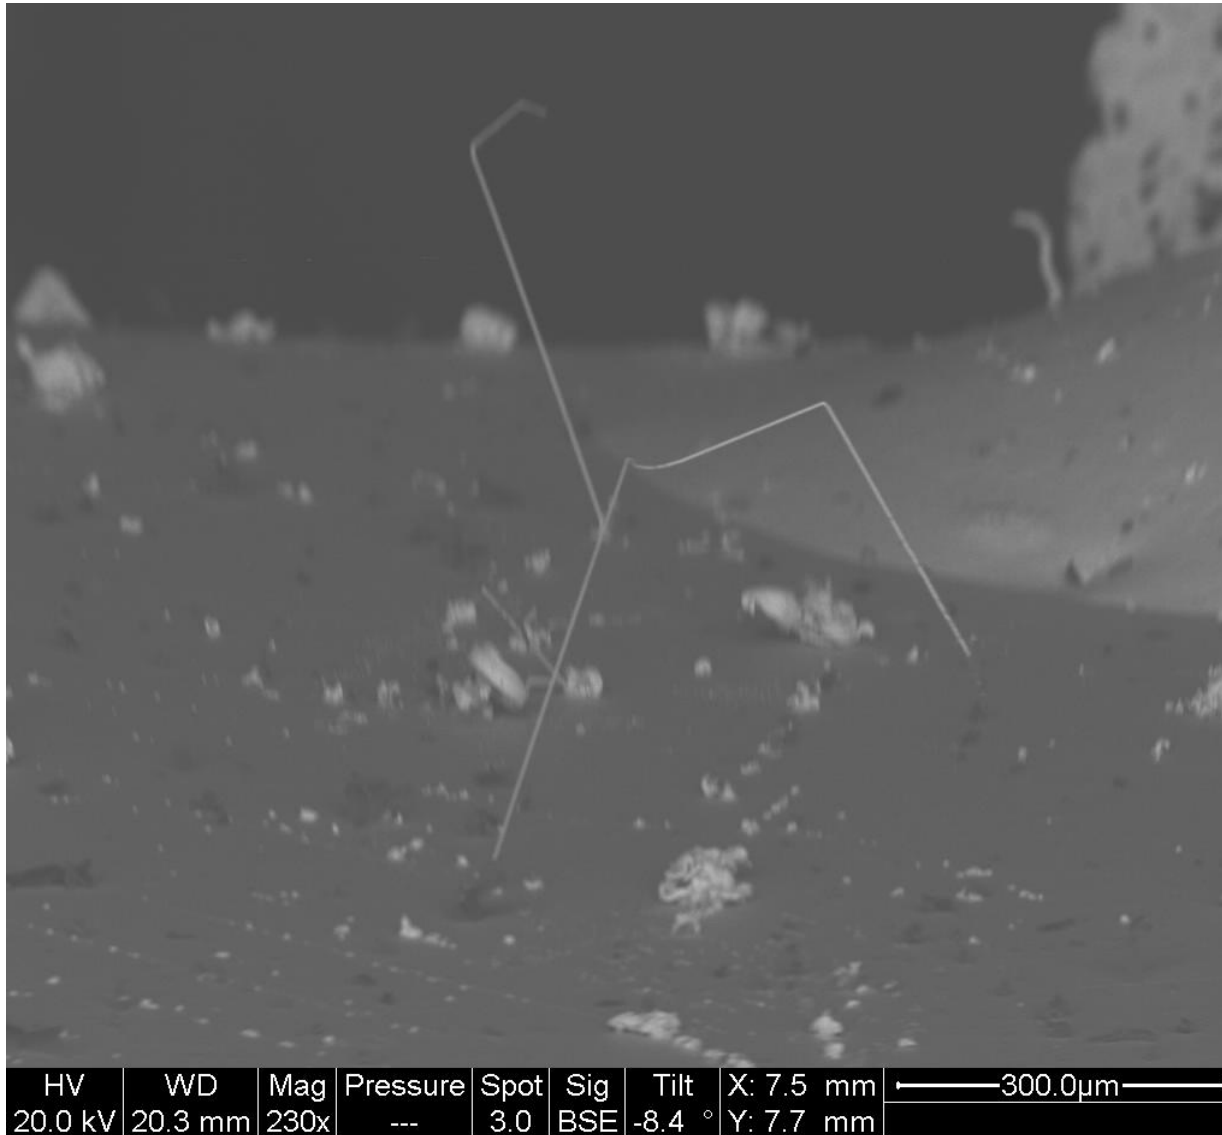
# ESEM Image of Long Whisker of USB
